Safety Alert:
"Reduced Visual References
Require Vigilance"

CFIT Accident: VFR into IMC

Spatial Disorientation Accident:
Dark Night VMC
Dennis J. Diaz, IIC

Spatial Disorientation Accident

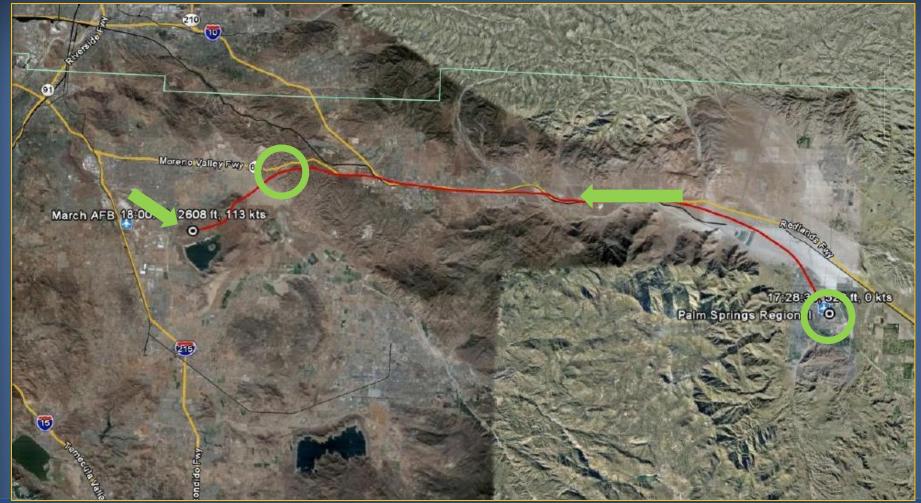
Accident Flight

- Aero Commander 680FL
- Mountainous terrain, daylight IMC
- Pilot was fatally injured
- Part 91, no flight plan
- Returning airplane to base after previous weather diversion

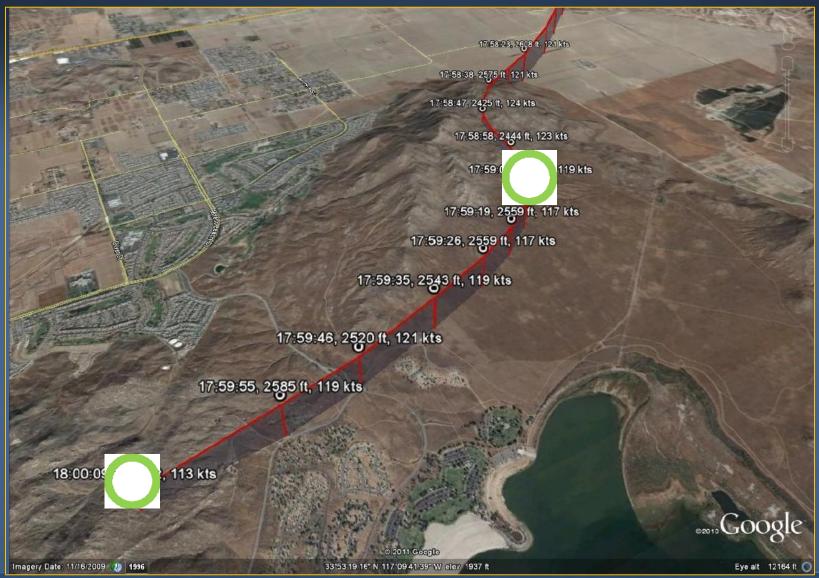
Accident Flight

- No record of a weather briefing
- Departure: VFR
- En route: marginal VFR
- Precipitation in area of accident

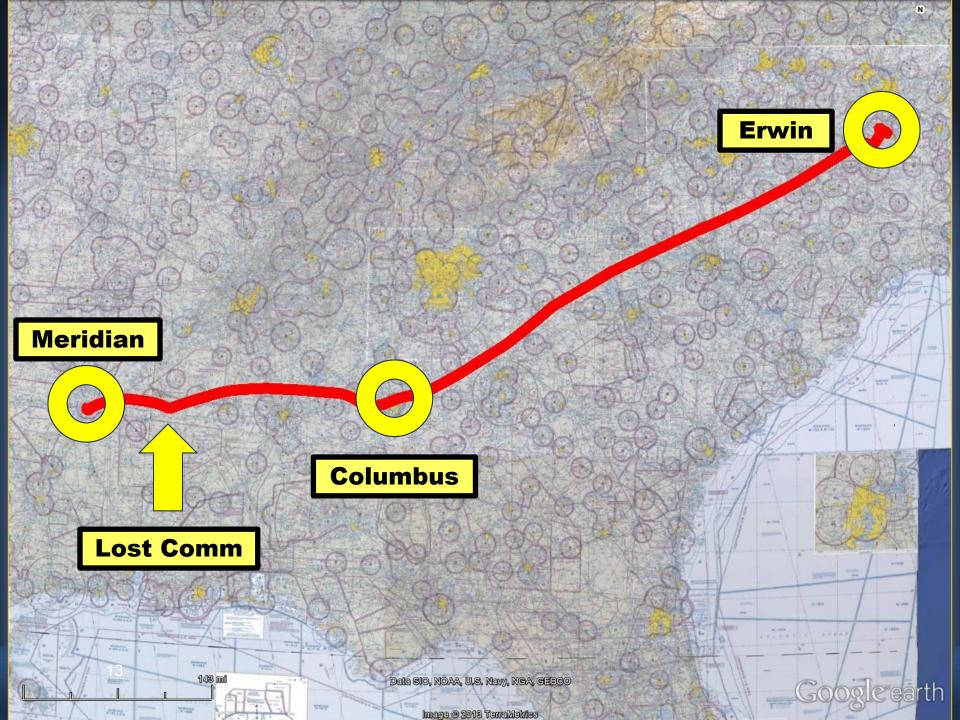
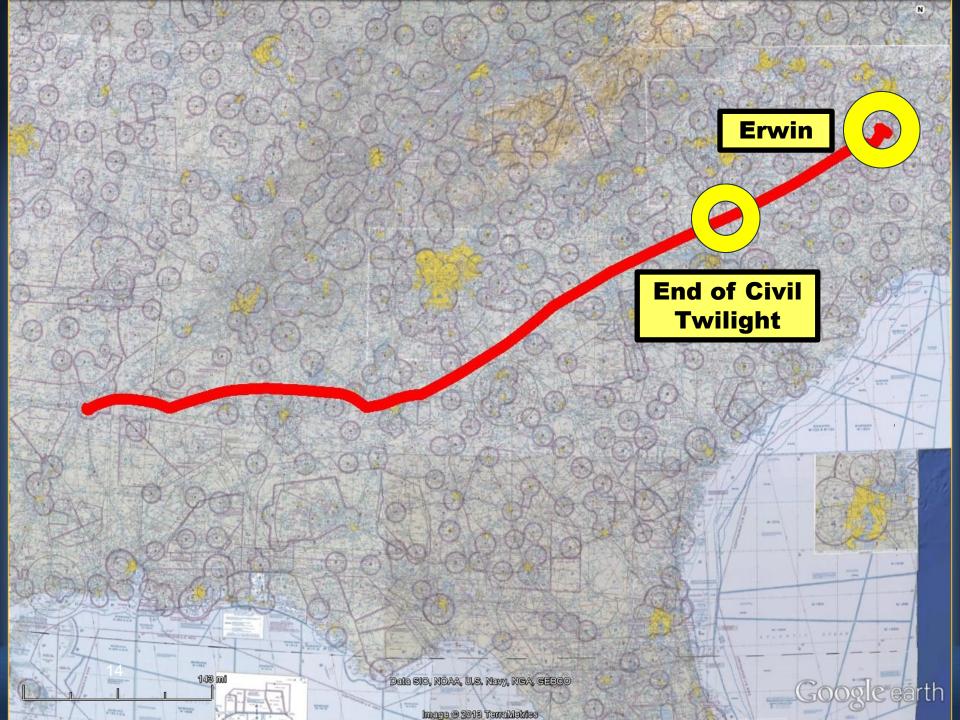
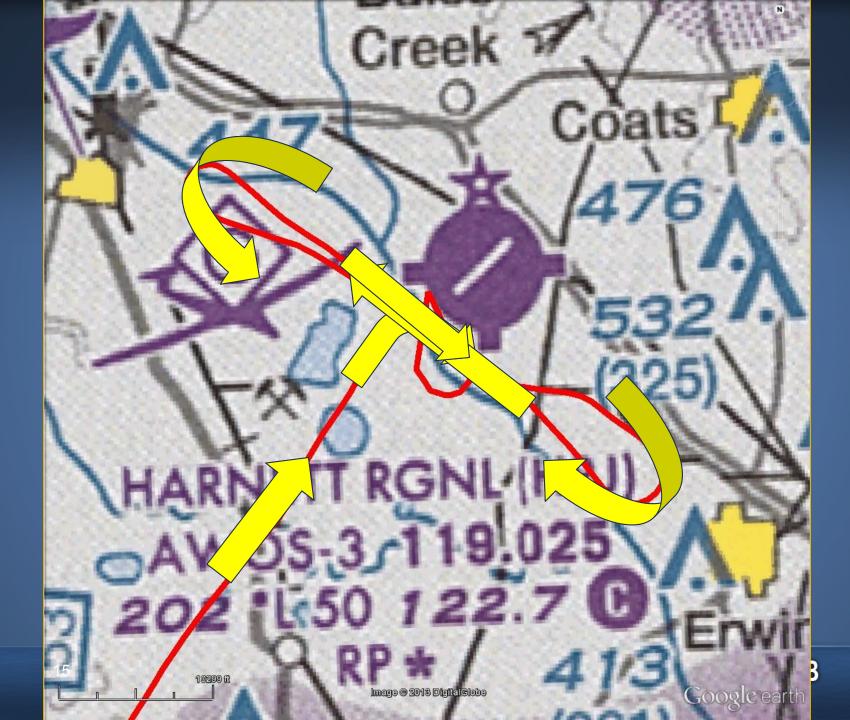
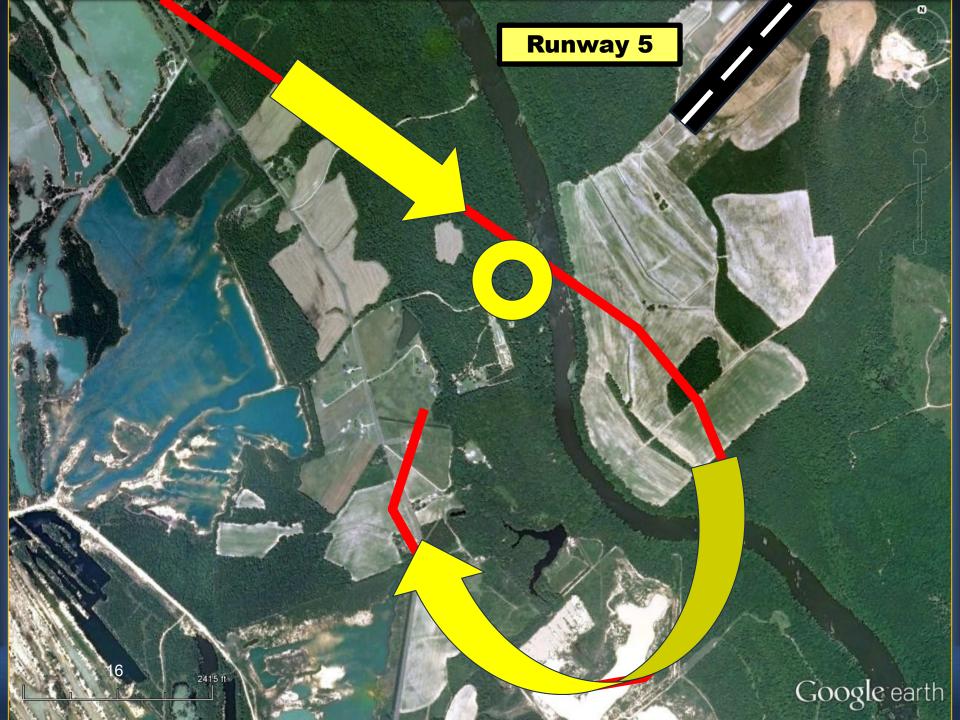
- Cessna 182S
- Dark night VMC
- Pilot and passenger were returning home
- Radio contact lost about 25 minutes into flight

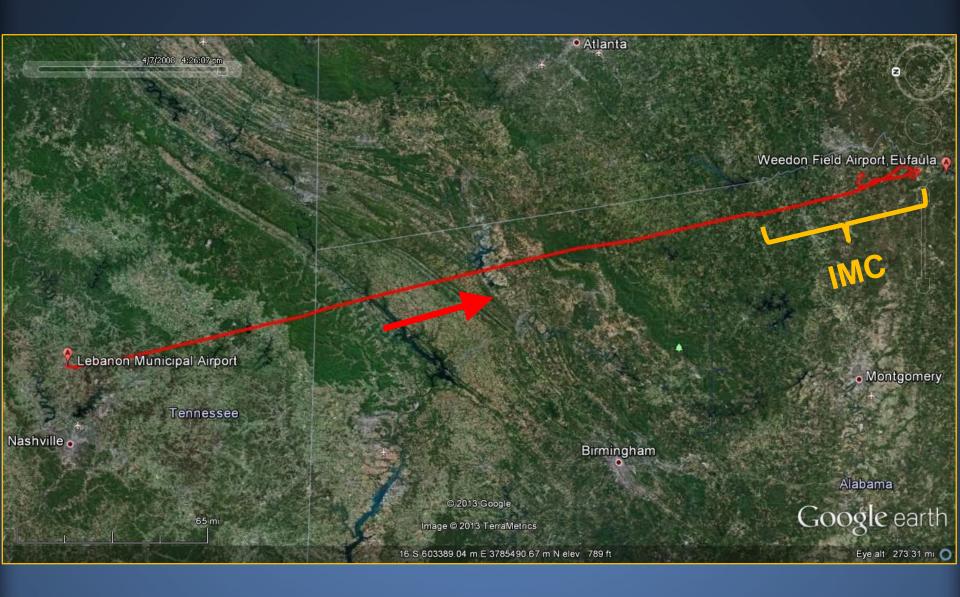
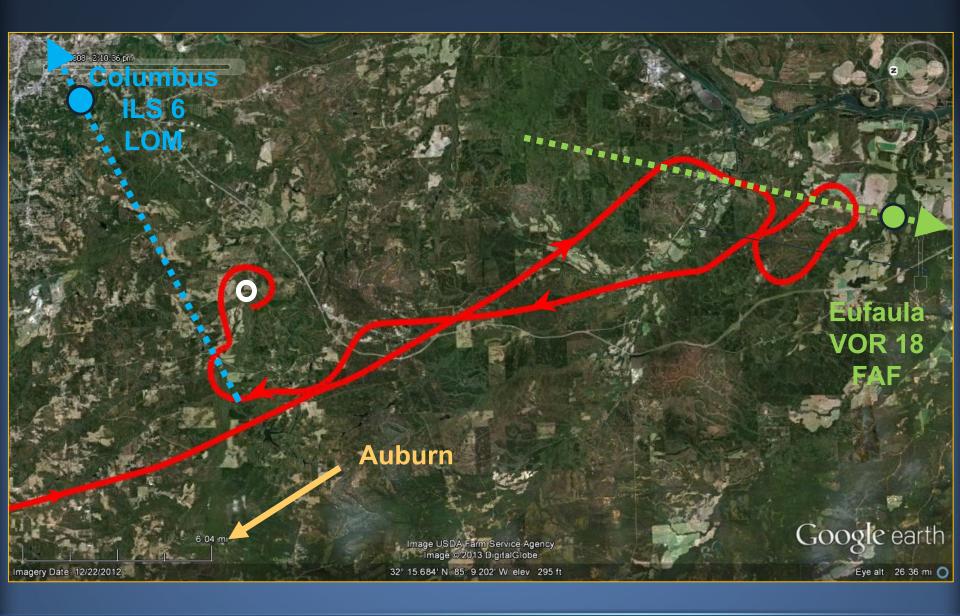
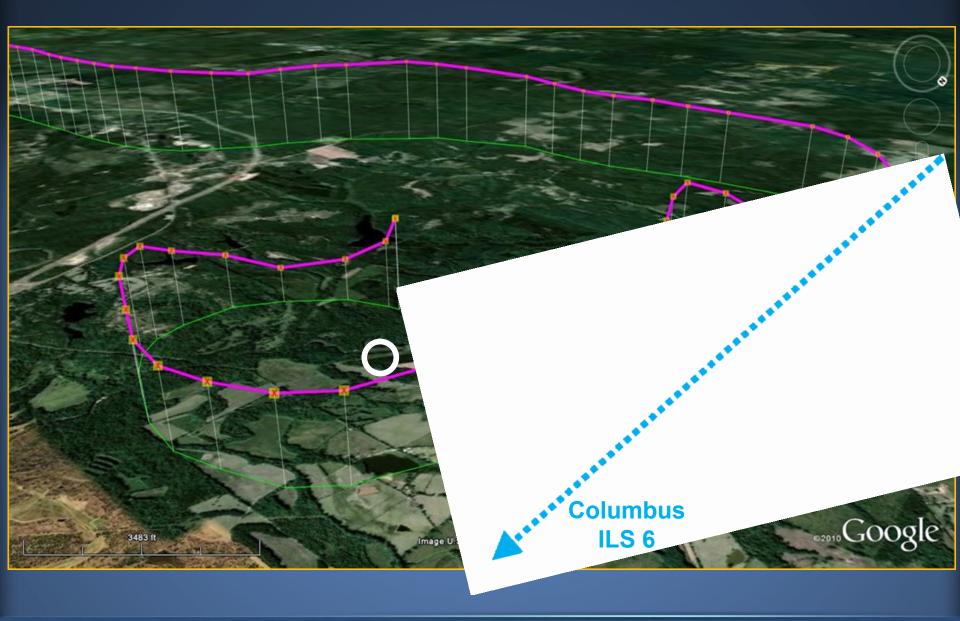
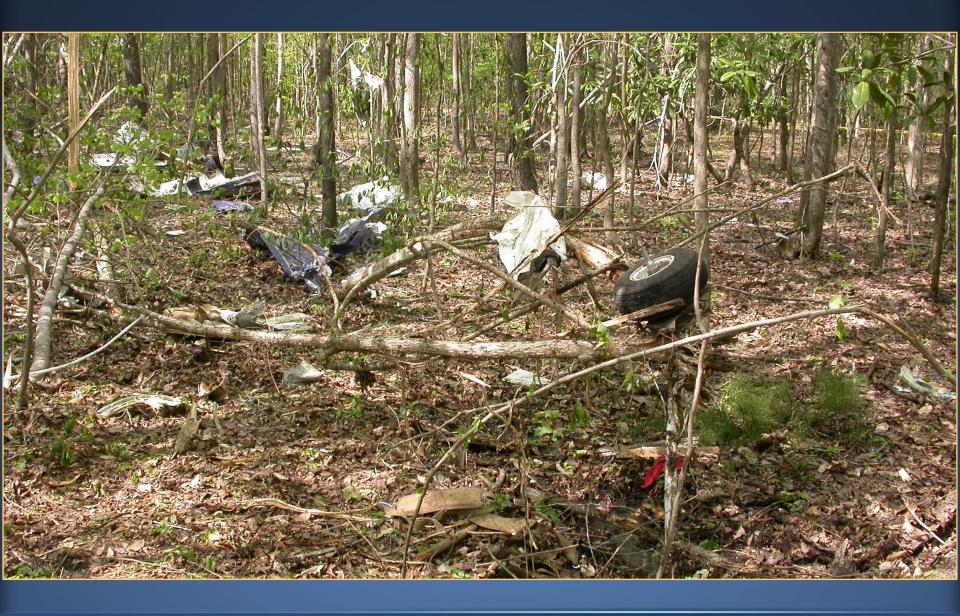
- Departure and en route: VMC
- Arrival area weather
 - 8 miles visibility
 - 1,000-foot ceiling
 - 4,500-foot cloud tops
